**International
Energy
Agency**

Condensation and Energy

Case studies

Report Annex XIV, Volume 4

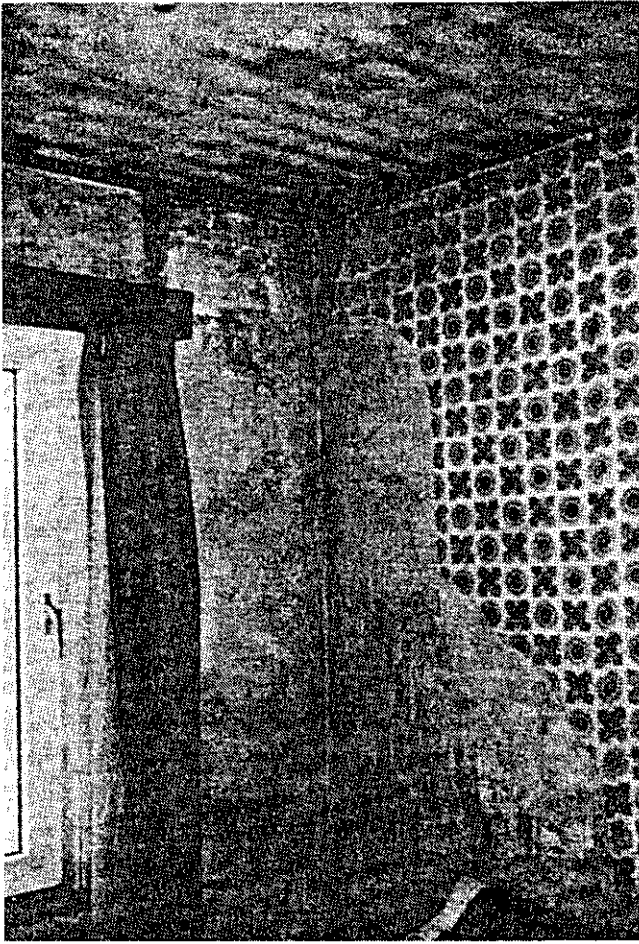
PHOTO 4.2
mould growth in a bedroom corner

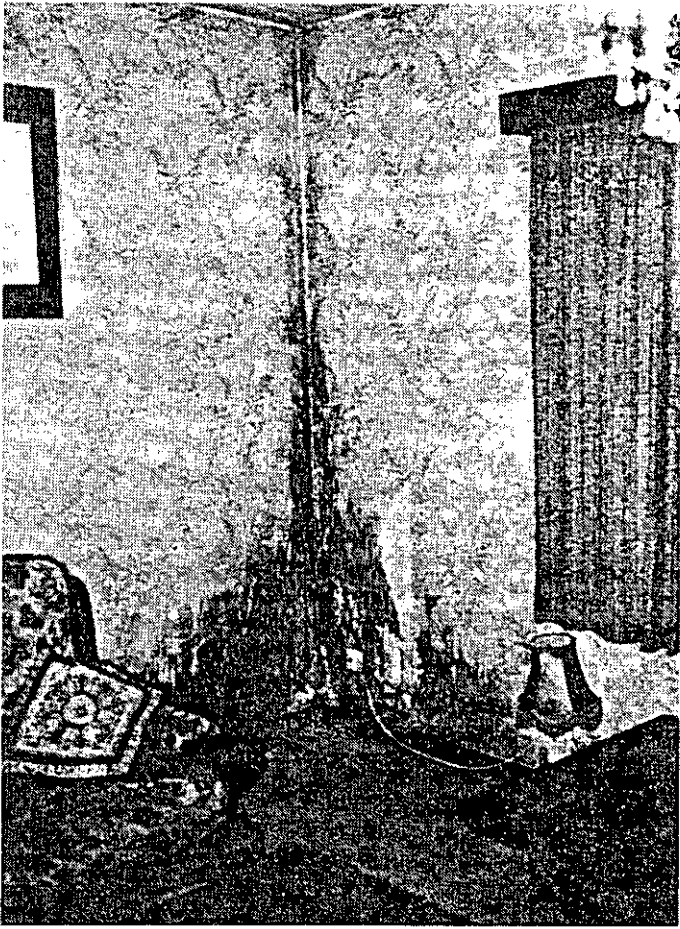
PHOTO 4.4
Mould in a 3-dimensional corner of the living room (Dwelling 1)

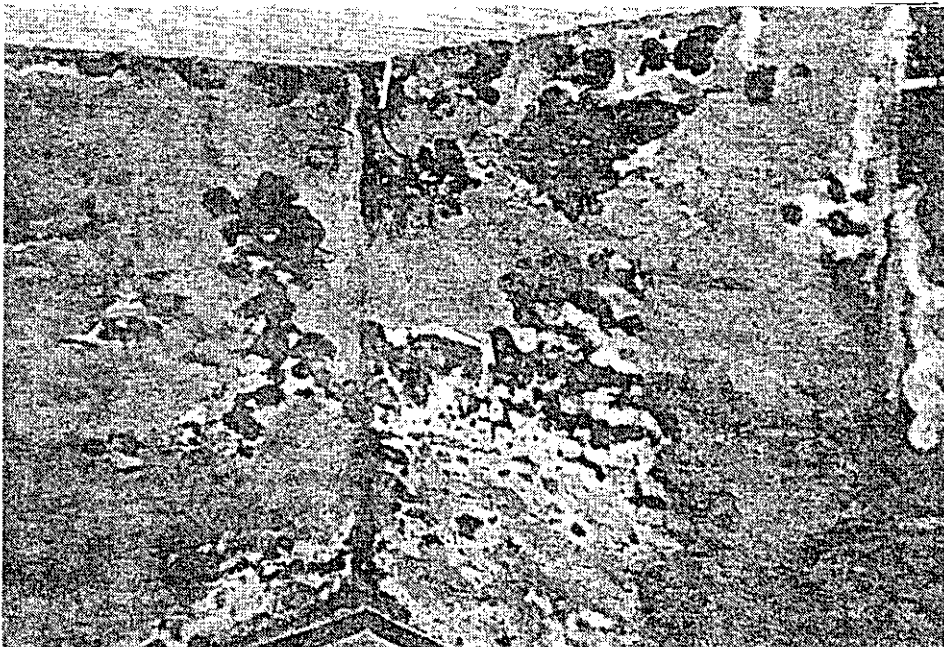
PHOTO 4.5
Rain penetration in the cellar.

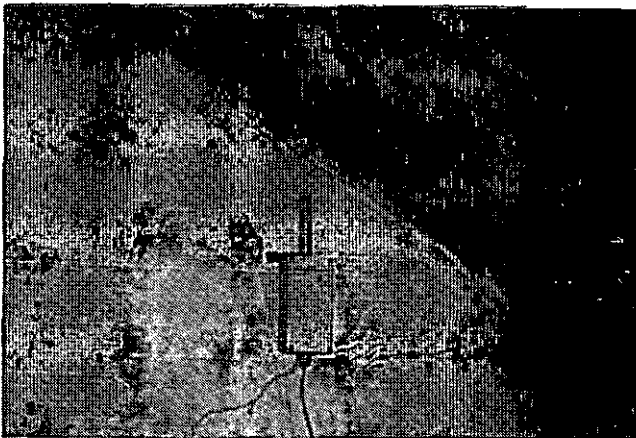
PHOTO 5.2

(Upper part of the hall in dwelling 2;
remark the intensive mould growth on the ceiling!)
measurement of the relative humidity
and air temperature

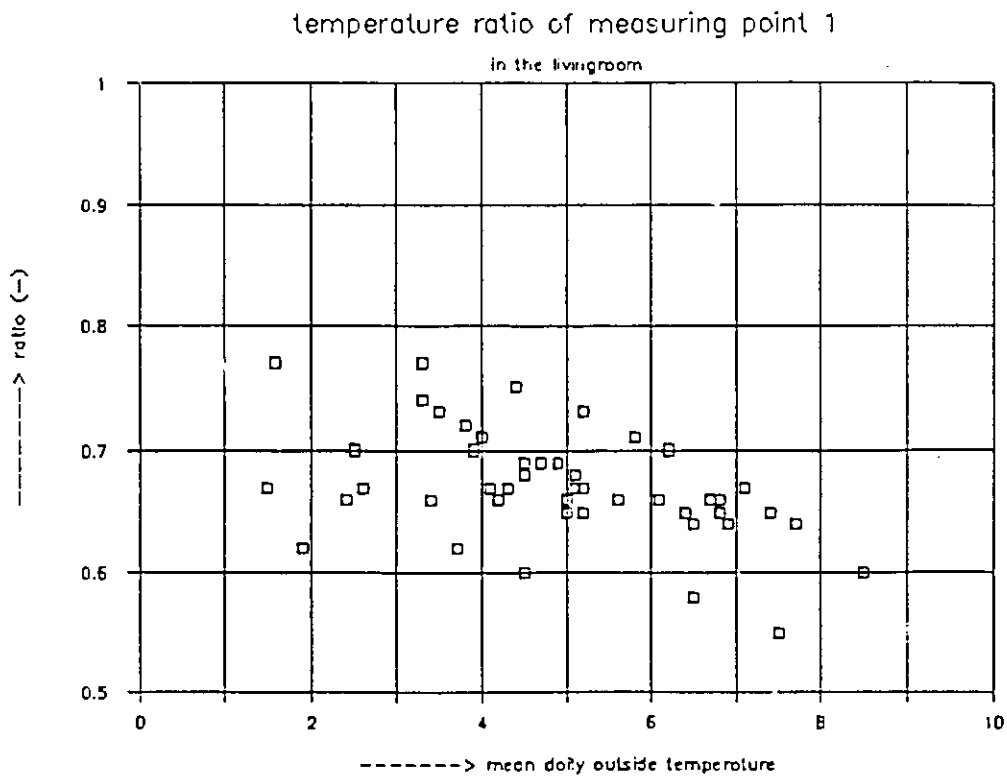
Figure 4.2 : Temperature ratio at 0.05 m above floor

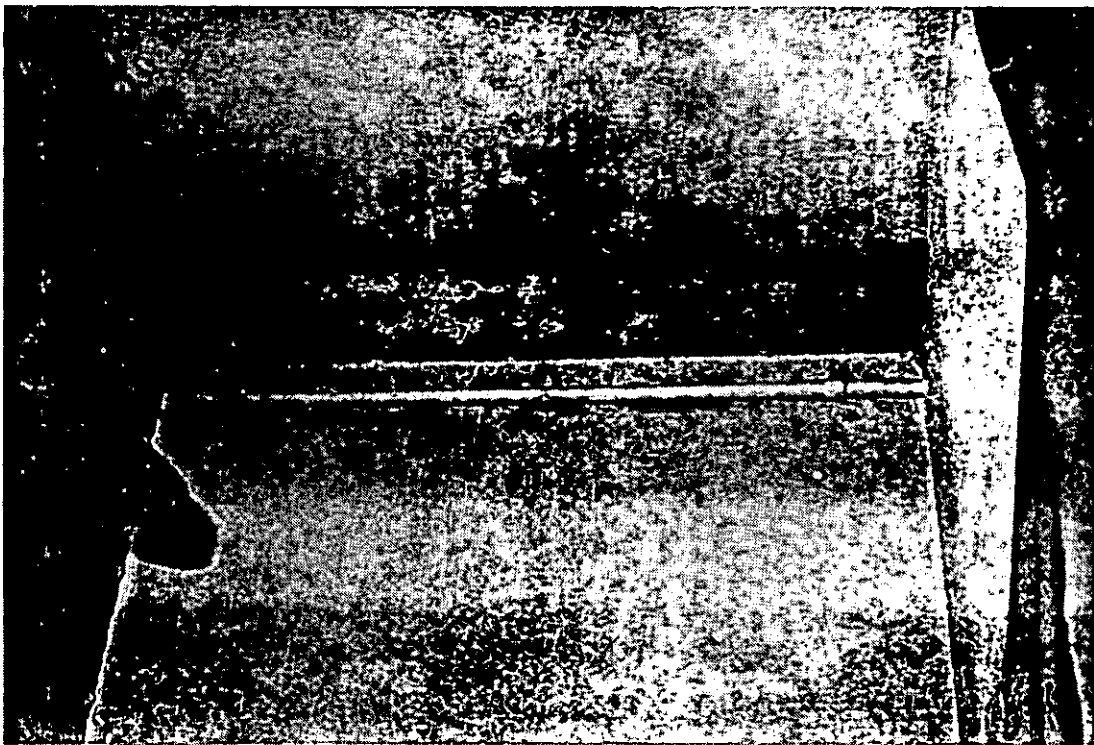
Photo 5.2 : Discoloration of walls and ceiling in the bathroom

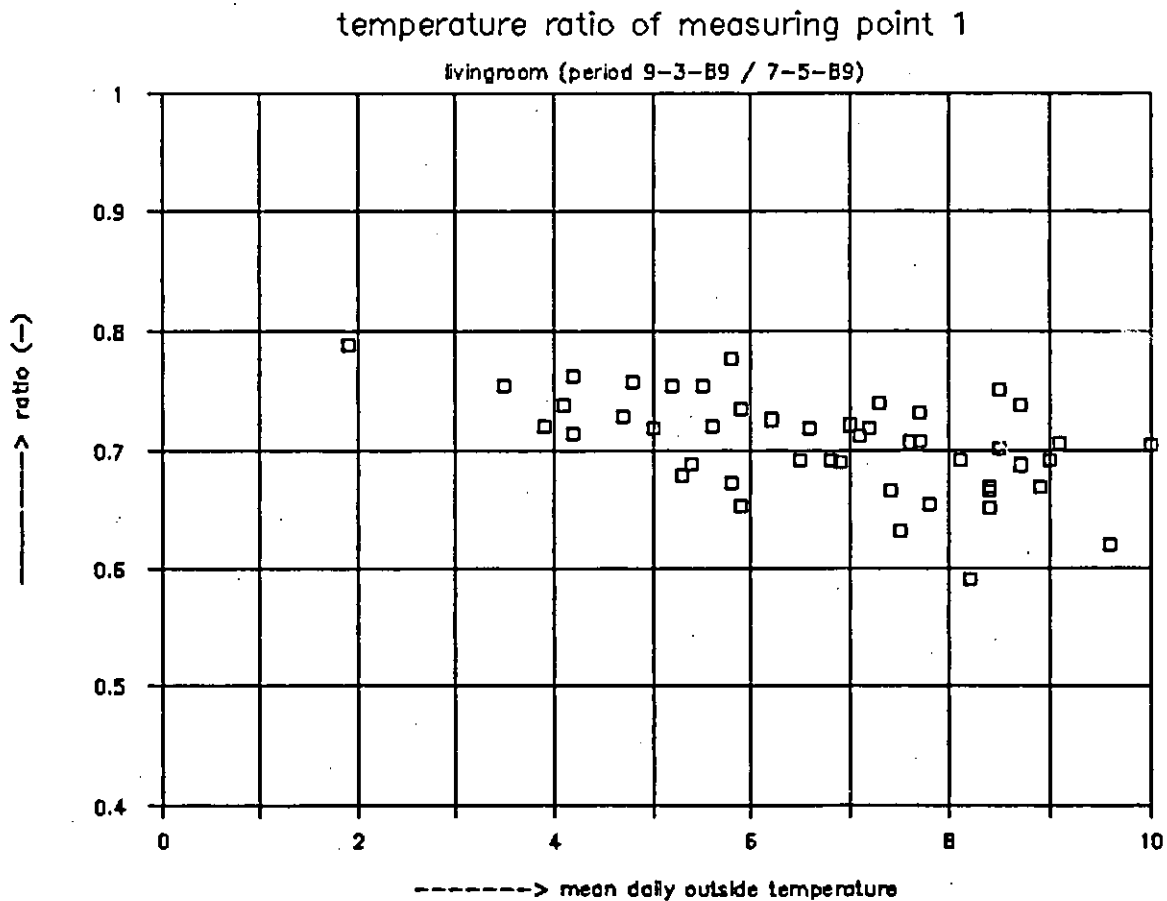
Moulds on the inner surface are probably an inheritance from the past. Refilling the lacks in the cavity wall-insulation results in a significant better temperature ratio τ during the winter period.

Figure 10.1.1 : Temperature ratio at 0.05 m above floor after refilling missing insulation

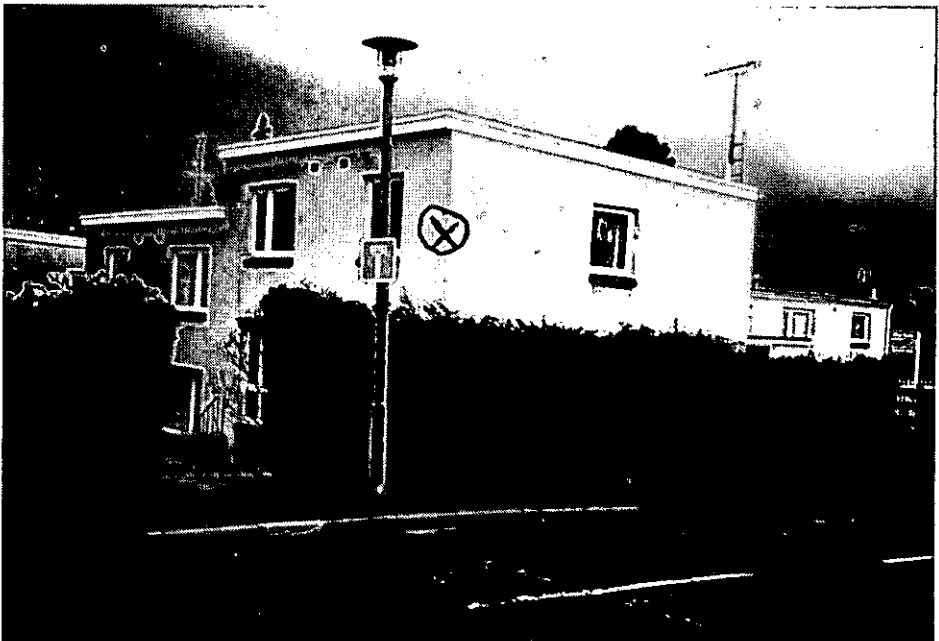
FIG 1.4 House 6 : end terrace/detached house ('X' shows the location of mould growth ; see section 3)

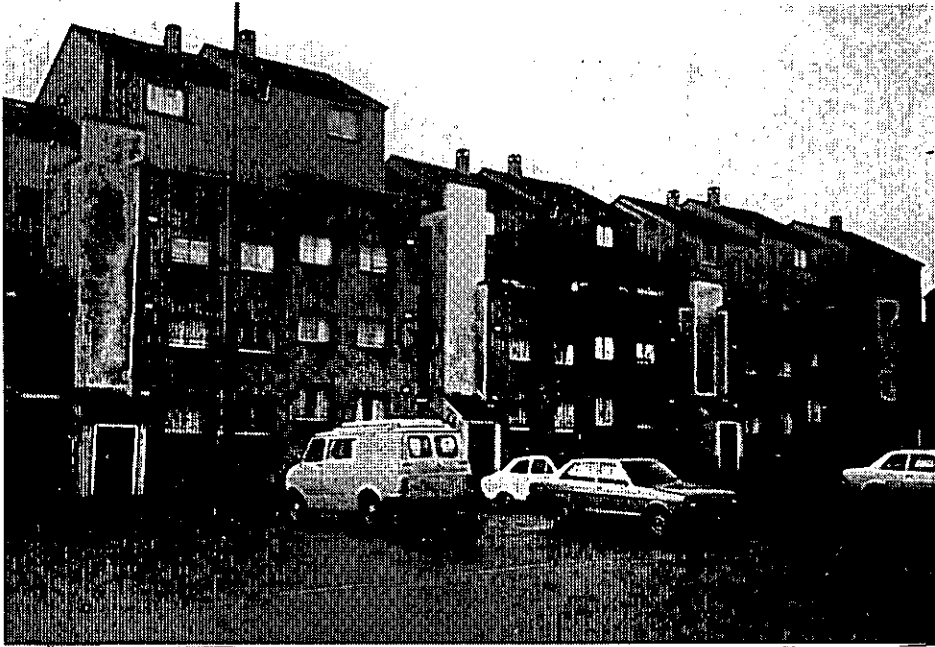
FIG 1.5 House 7 : first floor flat ('X' shows the location of mould growth; see section 3)

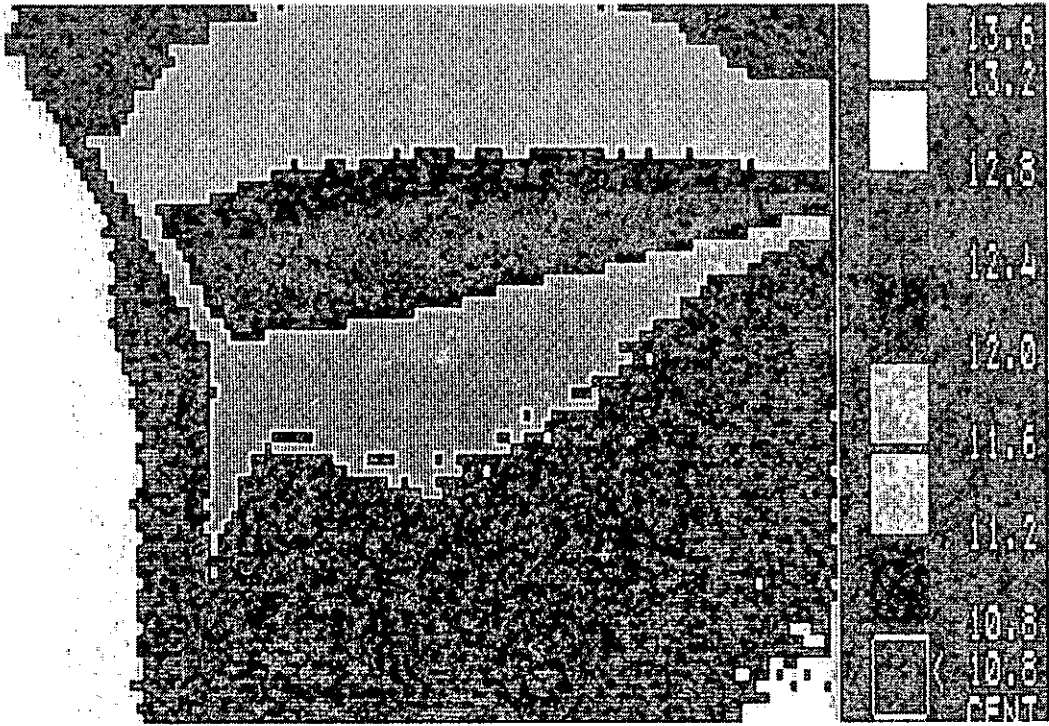
FIG 6.2 House 4: Thermal bridge at ceiling/external wall junction.
