**International
Energy
Agency**

Condensation and Energy

Case studies

Report Annex XIV, Volume 4

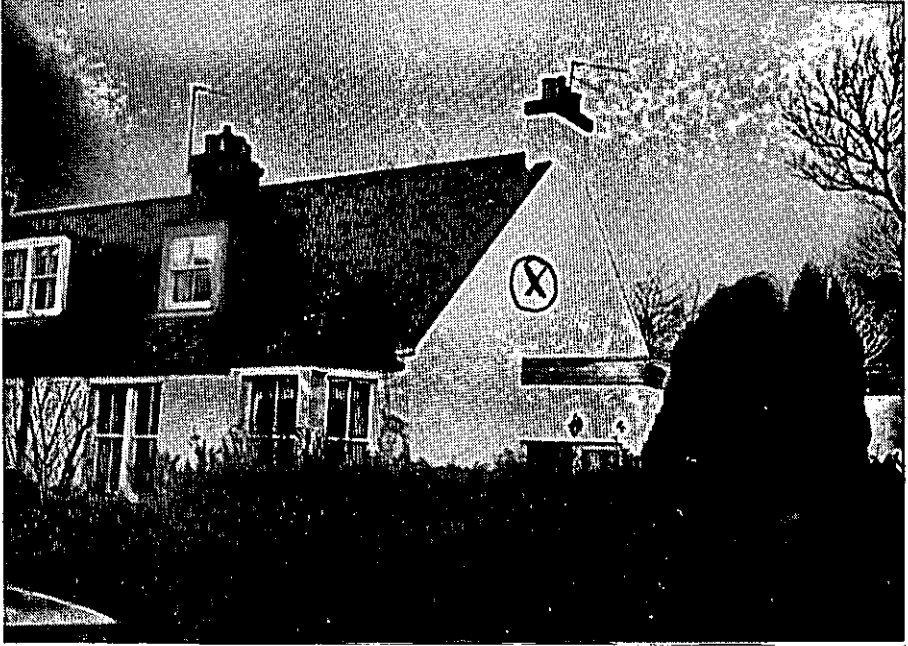
FIG 1.1 House 1 : end terrace 19th century ('X' shows the location of mould growth; see section 3)

- House 1 : extensive mould growth on the gable wall of one bedroom (figs 3.1 and 3.2; within location 'X' on fig 1.1). This had been present for a number of years; there was no evidence of rain penetration.
- House 2 : slight mould growth around the bedroom window reveals.
- House 3 : persistent mould growth 1-2 cm above ground floor level in two bedrooms.
- House 4 : slight mould growth in the window reveals.
- House 6 : persistent mould growth on an exterior corner; on the ground floor in an unheated hall off the kitchen (fig 3.3); on the first floor in a bedroom built in wall cupboard. (within location 'X' on fig 1.4)
- House 7 : mould growth on a external corner in a bedroom (fig 3.4; within location 'X' on fig 1.5)
