**International
Energy
Agency**

Condensation and Energy

Case studies

Report Annex XIV, Volume 4

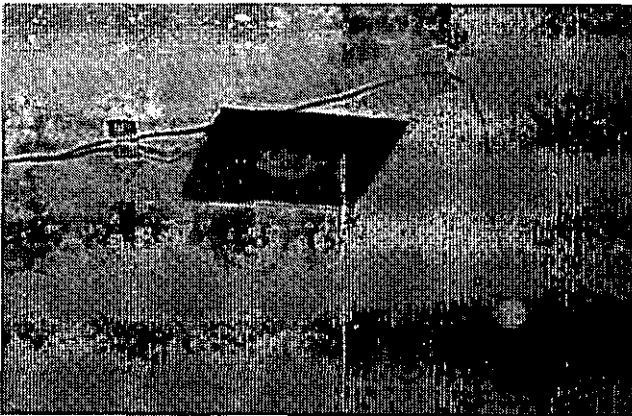
PHOTO 5.1

(ceiling bedroom 4, Dwelling 2)
